Landslide Hazard Assessment of Southeastern Minnesota

A thesis submitted to the faculty of
Winona State University by

In partial fulfillment of the requirements
for the degree of
Professional Science Master's

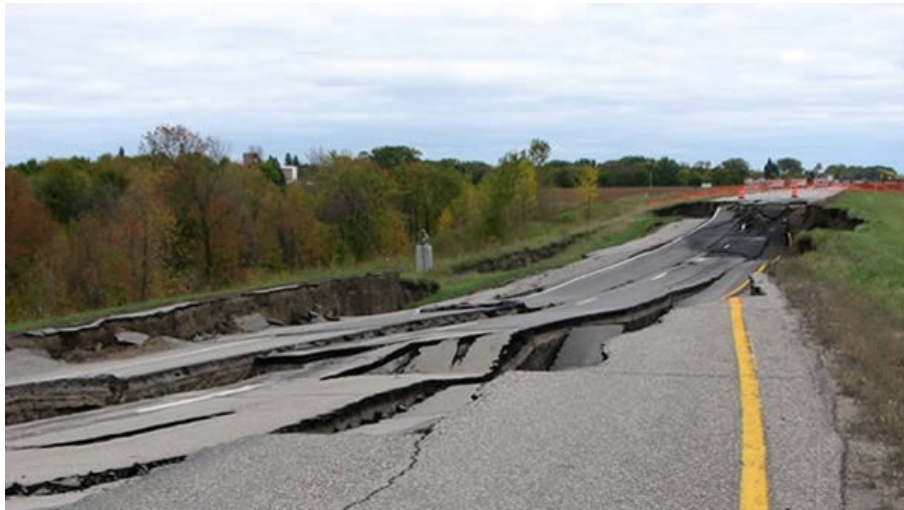
Figure 4. Highway 2 East of Crookston MN, collapsed due to rotational slumping.

Landslides occur on the western side of the state as well. In Crookston, Minnesota, a landslide in 2003 caused significant damage to a highway (Figure 4). Rotational landslides are common in the area around Crookston, near the Red Lake River. Landslides have been observed in the Crookston area since 1933 when a landslide destroyed a local hatchery. In order to better understand the cause of the landslides in Northwest Minnesota, automated landslide sensing instrumentation was installed to record data about the landslides. Researchers found that the landslides occurring in the Red Lake River area occurred most commonly in the fall when the water level was at its lowest because when hydrostatic pressure is lower, it causes slope creep to increase (Dasenbrock et al., 2012).

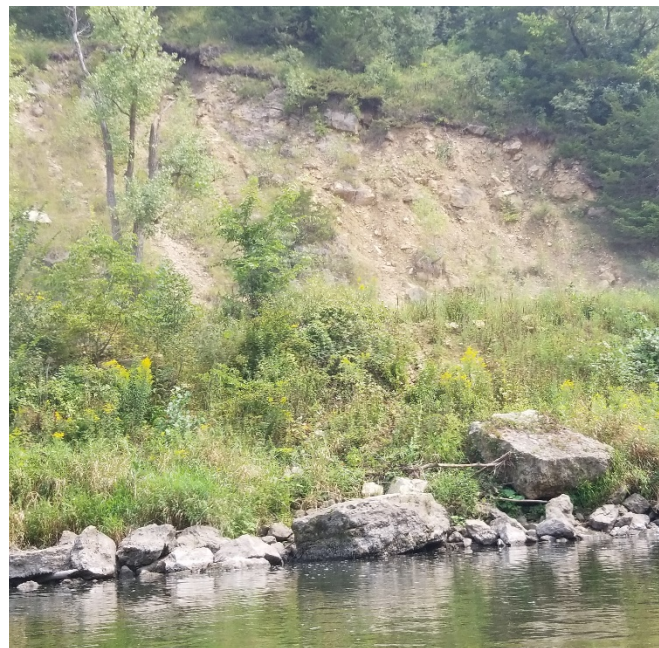
Figure 9. Translational debris slide along the Zumbro River in Wabasha County, MN
